Eyes Over Puget Sound

Water column

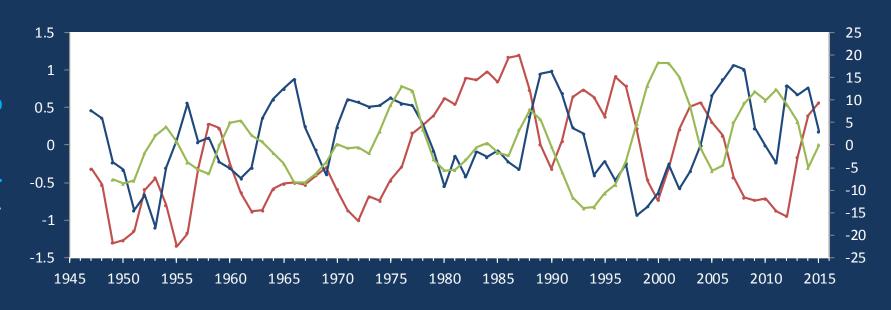
Ocean boundary conditions are in transition: (a) water is warm (PDO), (b) upwelling of low oxygen and high nutrient ocean water is expected (Upwelling Index), and (c) higher surface productivity along the coast (NPGO) is expected. Where are we heading next?
